# San Fernando, California, Earthquake of February 9, 1971

LEONARD M. MURPHY  
*Scientific Coordinator*

*Volume I*

*Part B.* Buildings *continued*; Soils and Foundations

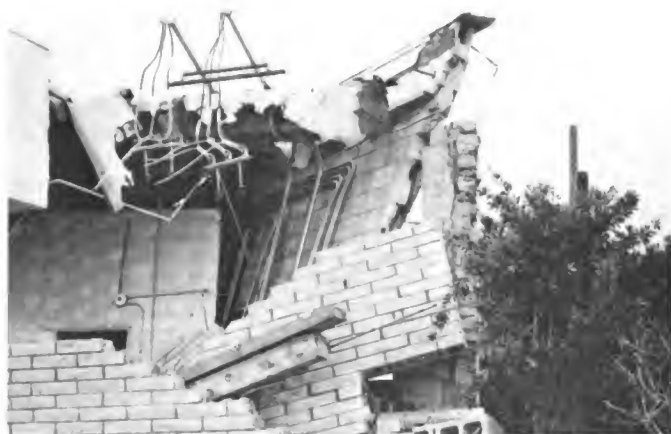
Figure 2.—Stone's Liquor Store. Concrete block wall at southeast corner of building.

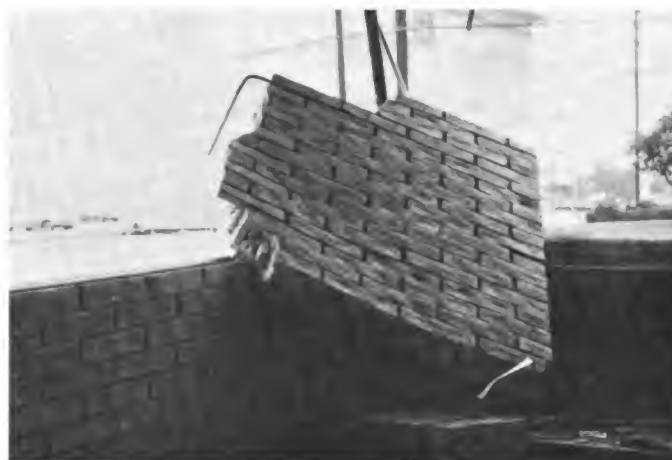
Figure 4.—Stone's Liquor Store. Remains of short shear wall located at southwest corner of building.

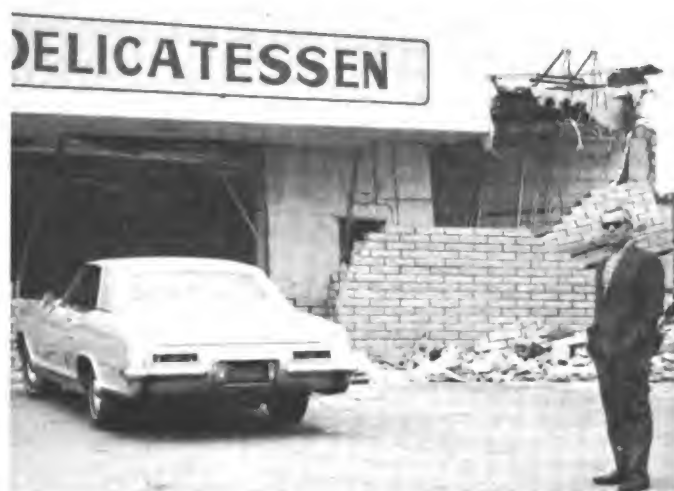
Figure 3.—Stone's Liquor Store. Southeast corner of building. Bent steel pipe column can be seen to the left of collapsed pier.

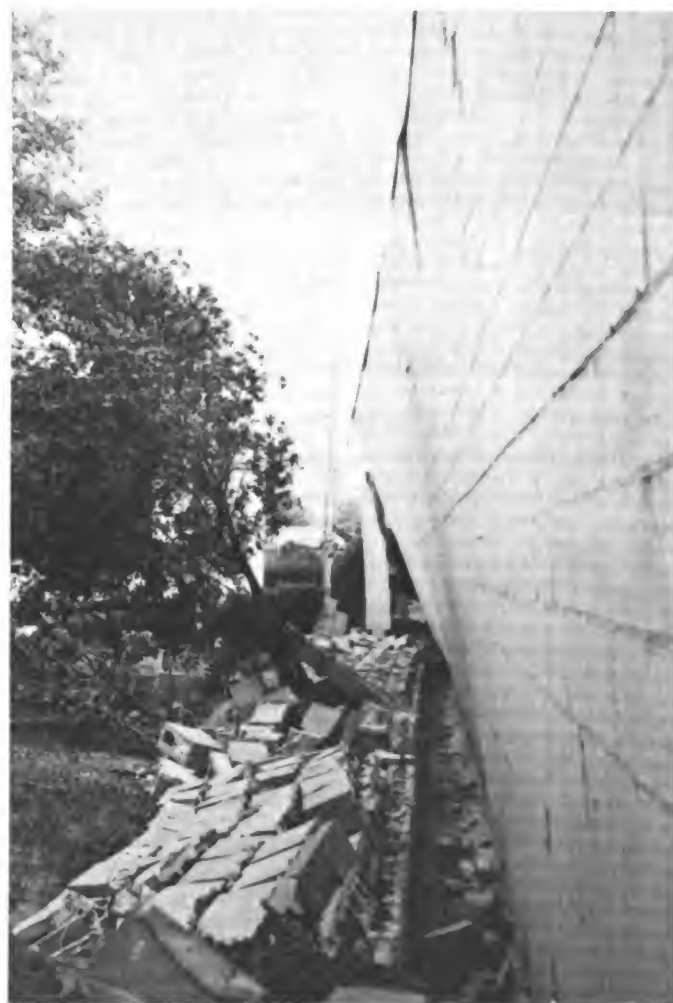
Figure 5.—Stone's Liquor Store. East wall of building. Apparently, an adjacent and much shorter block fence wall was knocked down by taller building wall.

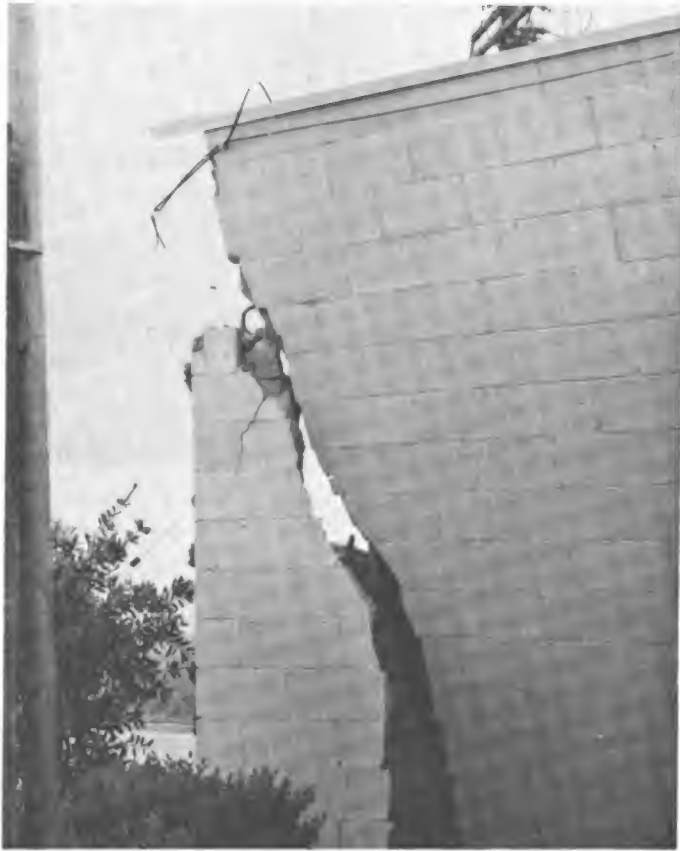
Figure 6.—Stone's Liquor Store. Southeast corner of the building looking from east.

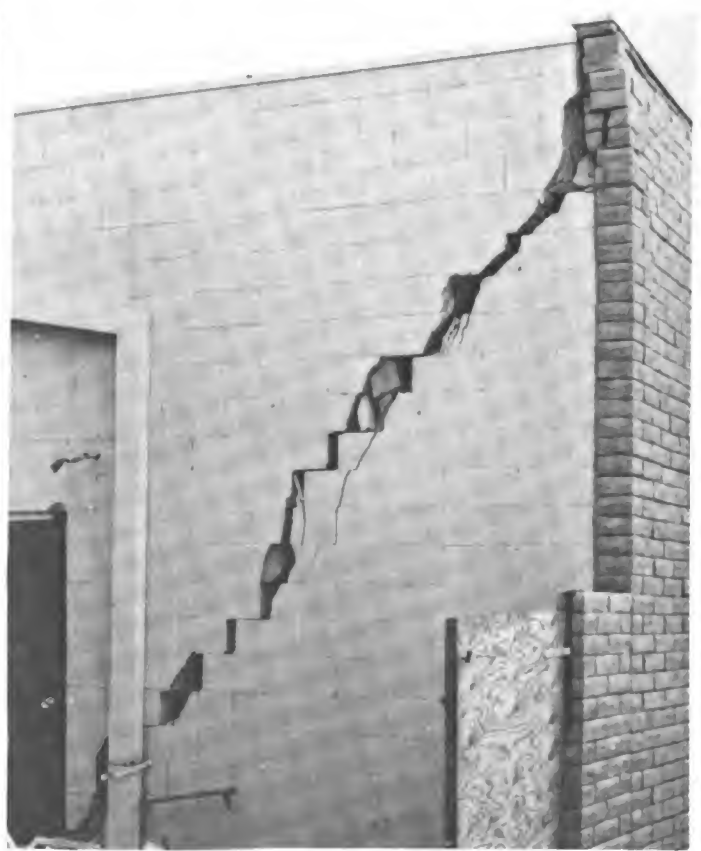
Figure 7.—Stone's Liquor Store. North concrete block wall severely cracked.

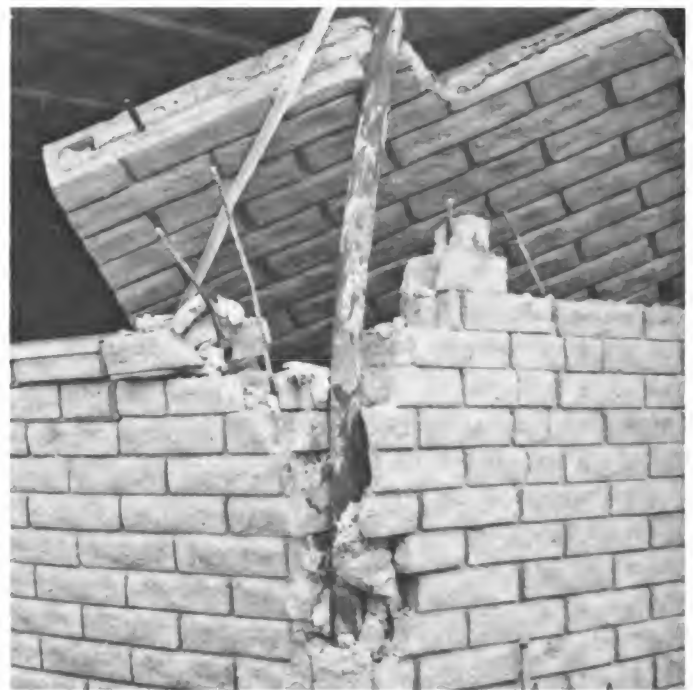
Figure 8.—Stone's Liquor Store. Southwest corner of building. Collapsed shear wall and bent steel pipe column enclosed within wall.

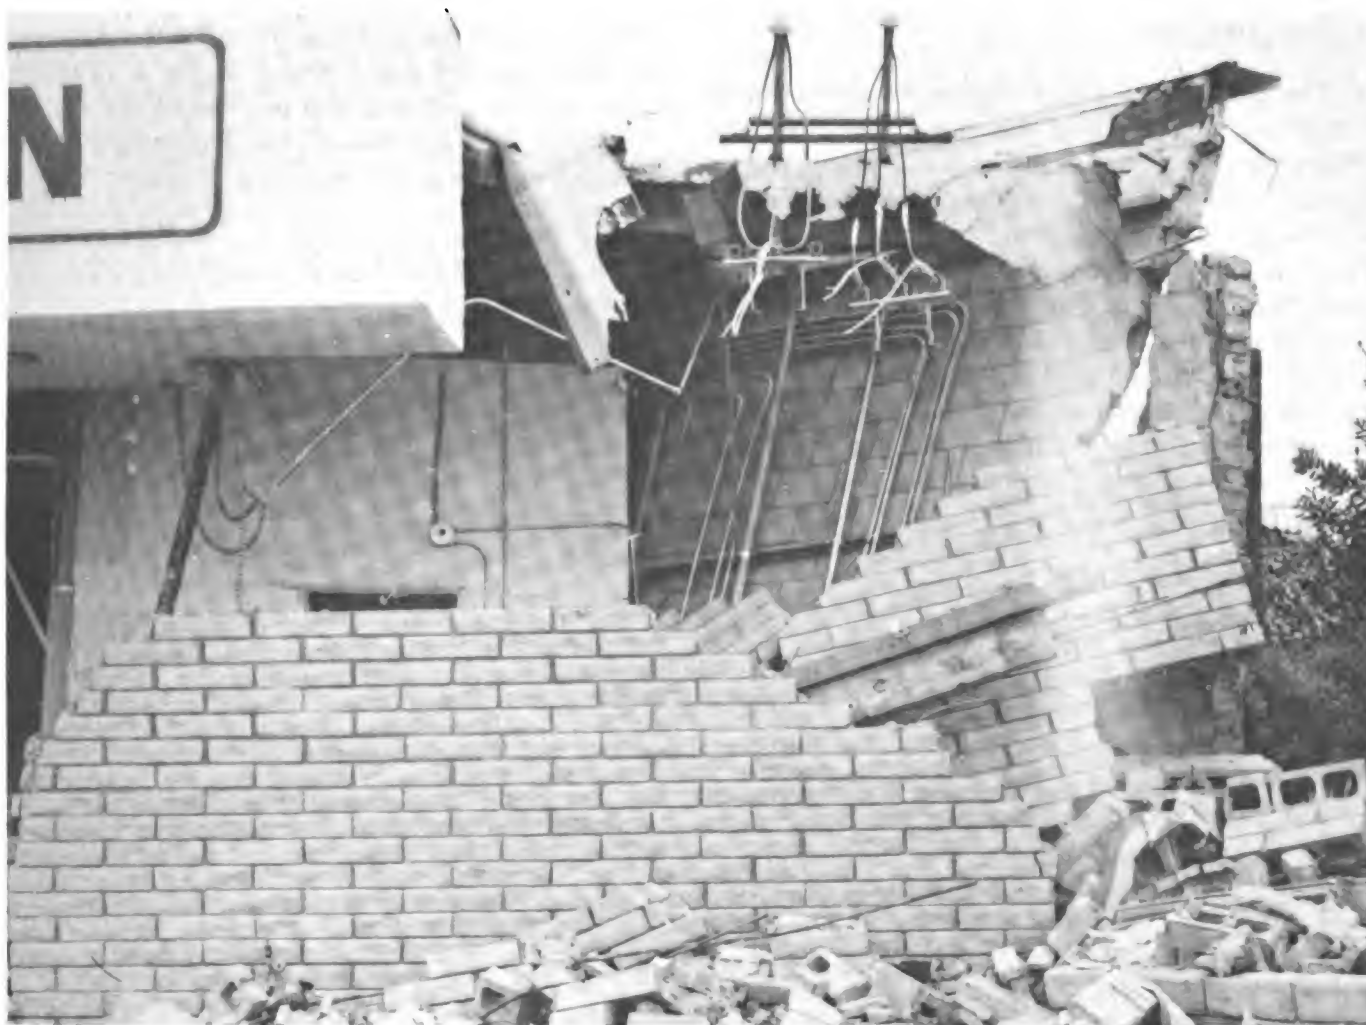
Figure 9.—Stone's Liquor Store. Collapsed shear wall at southeast corner of building.

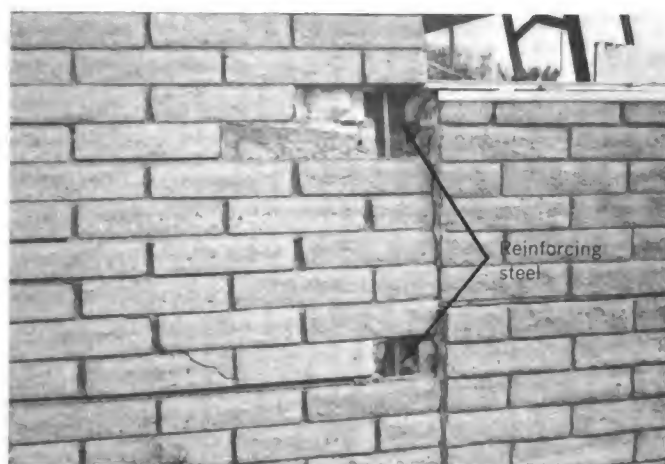
Figure 10.—Stone's Liquor Store. Cell with reinforcing steel does not appear to contain grout.

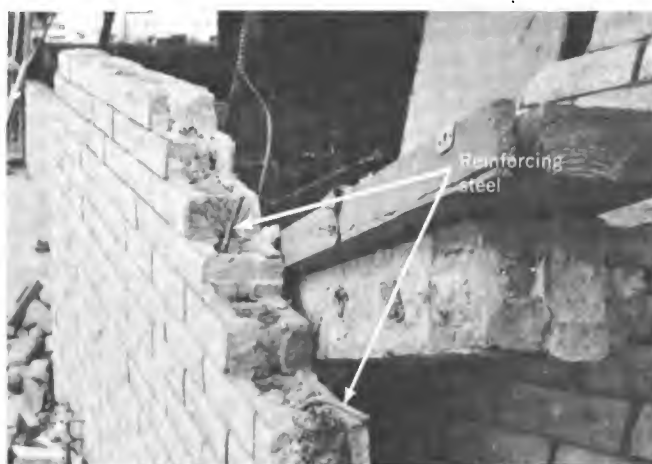
Figure 11.—Stone's Liquor Store. Collapsed full-height wall shows upper end of reinforcing steel. Lack of grout in cell with reinforcing is also apparent.

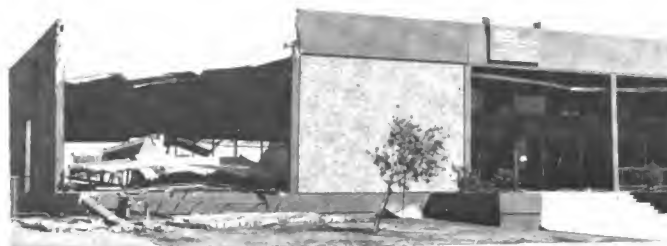
Figure 2.—Warehouse Building. Concrete beams and column framing at northwest corner of the building collapsed. Note broken glass in entrance area. Los Angeles City Department of Building and Safety photograph.

the building were broken; frames and mullions jammed and buckled (fig. 2).

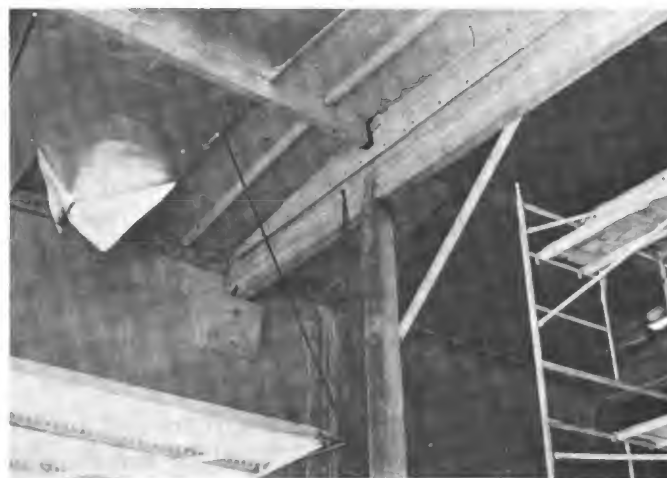
Glued laminated girders on line 2 (fig. 1) fell with the roof. Wall corbels supporting laminated girders were cracked, and the connection between both elements became ineffective. Several girders sustained either longitudinal cracks or partial separations of laminations.

Figure 3.—Warehouse Building. Glued laminated girder with gusset plate where split or delamination occurred. Repaired corbel on wall. Wheeler & Gray photograph.

ments severely damaged. Steel gusset plates were bolted to the glued laminated girders to reinforce the areas where cracking and separations occurred (fig. 3). Reinforced concrete that collapsed at the northwest corner of the building was repoured (fig. 4). Cracks in concrete were pressure injected with epoxy resin compounds, and almost every corbel had to be rebuilt after all of the affected concrete was removed (figs. 3 and 5). It is estimated that the cost of earthquake repairs was about \$80,000, which represents about 25 percent of the value of the building.

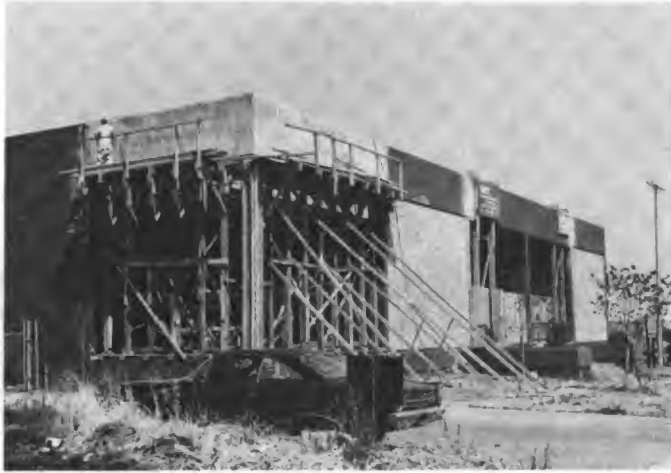
*Figure 4.—Warehouse Building. Reconstruction of reinforced concrete structure at northwest corner of building. Wheeler & Gray photograph.*

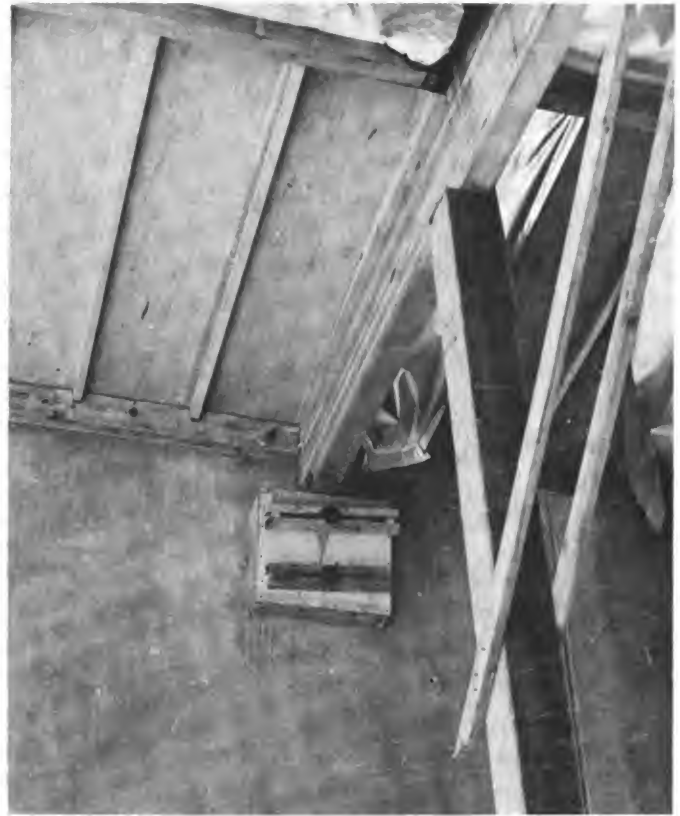
The connection between the girders and corbels consistently failed under the level of forces originated by this earthquake.

*Figure 5.—Warehouse Building. Wall corbels had to be repoured. Girder rests on temporary shoring. Wheeler & Gray photograph.*

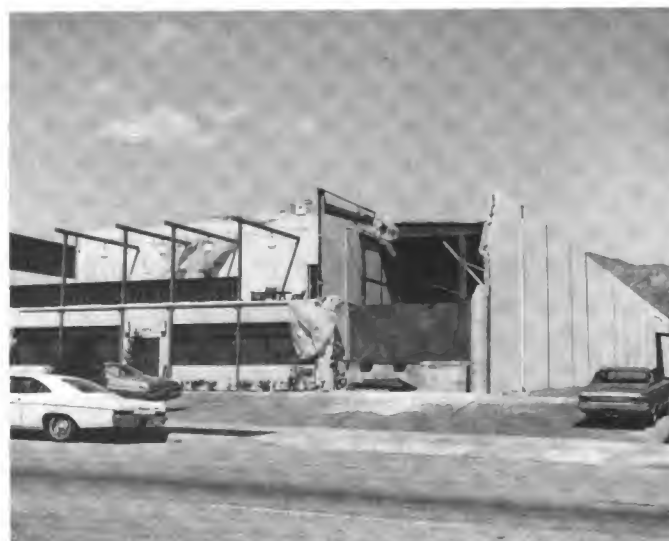
The east wall of the building and adjacent roof collapsed. The high west façade wall at the loading dock and the immediate roof supported by the wall also collapsed (fig. 4). It can be assumed safely that the roof sheathing and/or wood ledger separated from the wall at these areas. The walls and roof purlins lost their horizontal and vertical supports, respectively, with collapse of the wall and roof following.

Figure 4.—All Phase Color. West elevation of building. Precast concrete panel and adjacent roof collapsed. Los Angeles City Department of Building and Safety photograph.

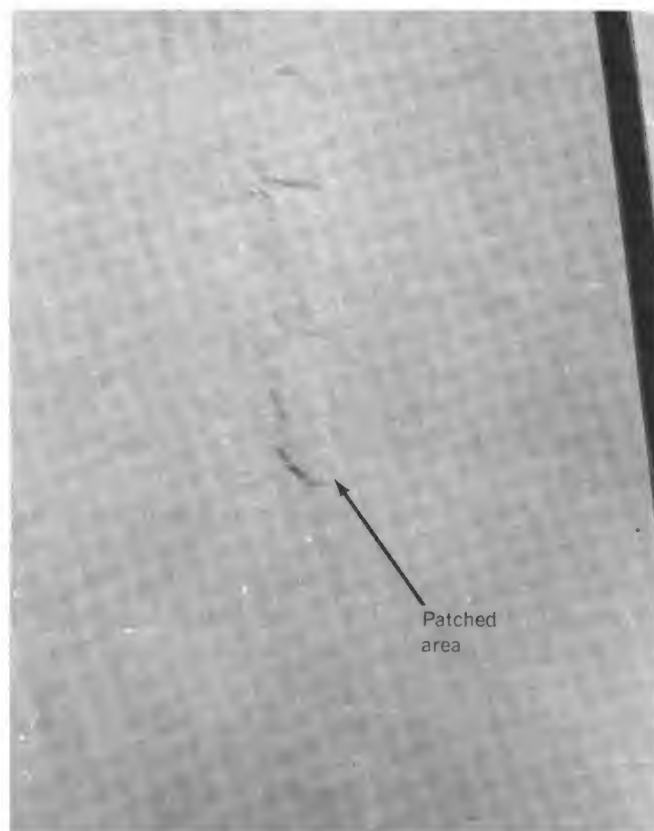
Figure 5.—All Phase Color. North wall, looking from outside the building. Though repaired, damage inflicted by displacement of interior wall is evident. Wheeler & Gray photograph.

Ground movements displaced the transverse precast shear wall on line 3.3 (fig. 2) approximately 4 inches in a north-south direction, inflicting severe damage to the exterior precast panels connected to this wall (fig. 5). Most exterior concrete walls exhibited cracking in random directions.

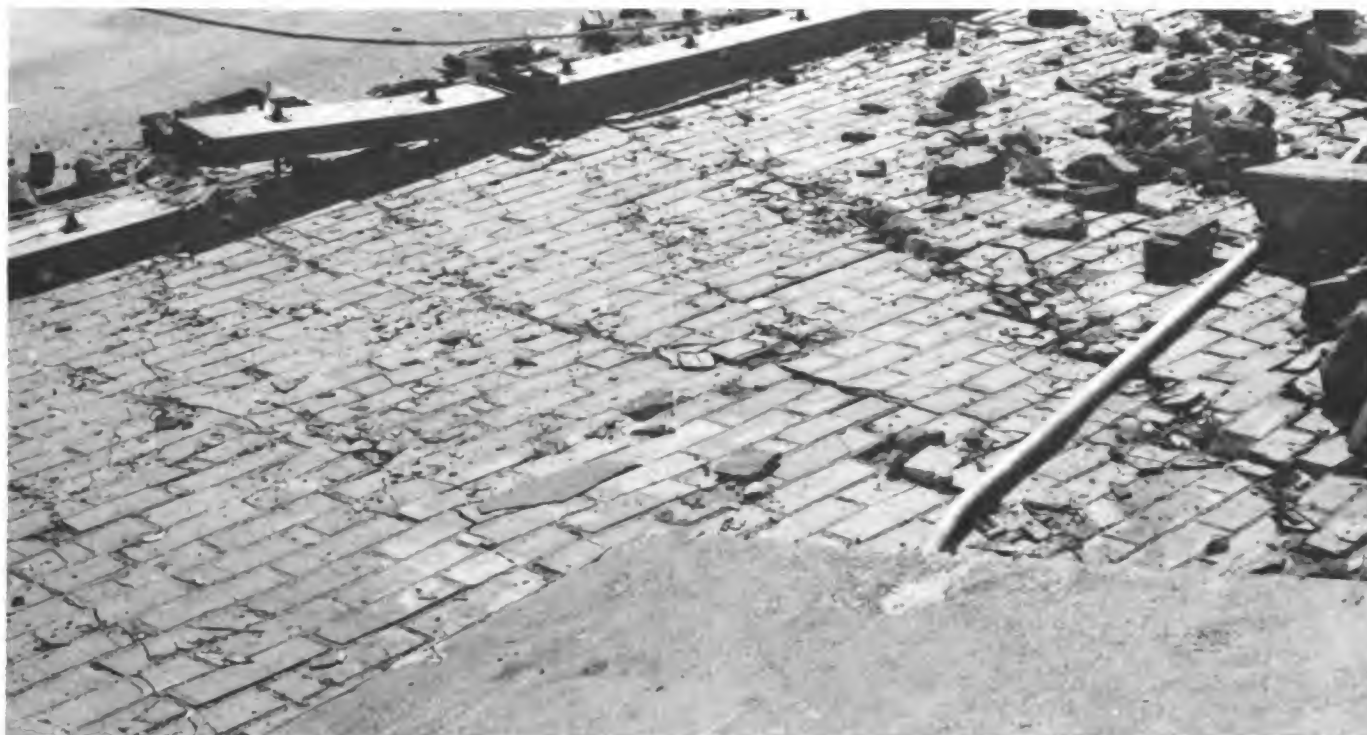
No major soil disturbance seemed to have affected the immediate area where this building was located. Only some minor ground cracking was visible. The rear (south) wall of the building collapsed after los-

ing lateral support at the roof (figs. 3 and 4). The nailing connecting the plywood roof to the ledger ripped through the edge of the plywood. Even though the ledgers did not fail, some of them showed serious splitting (fig. 5). The front wall of the building also was loosened from the roof but did not come down. Apparently, the wall returns at the entrance lobby helped to prevent the wall from collapsing. One of the side walls (west) moved out several inches at the front two bays, and the bolts connecting the ledgers to the wall pulled loose at the first bay only.

*Figure 3.—Bell Metrics. South wall of building on ground after collapse. Wood ledger still attached to wall in upper part of photograph. J. F. Meehan photograph.*

This structure was rebuilt to preearthquake conditions including some minor changes that were requested by the Los Angeles City Building Department. One of them was the addition of steel straps bracing from rebuilt walls to roof members (fig. 2, details 1 and 2). The other was the use of  $\frac{1}{2}$ -inch plywood with heavier nailing for that section of roof that collapsed (fig. 1).

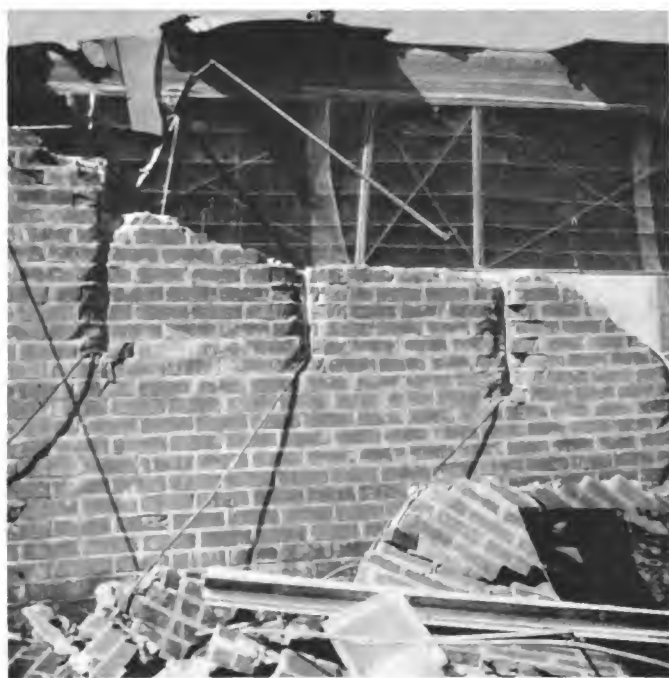
*Figure 4.—Bell Metrics. South wall collapsed. Note vertical reinforcing torn from brick wall. J. F. Meehan photograph.*

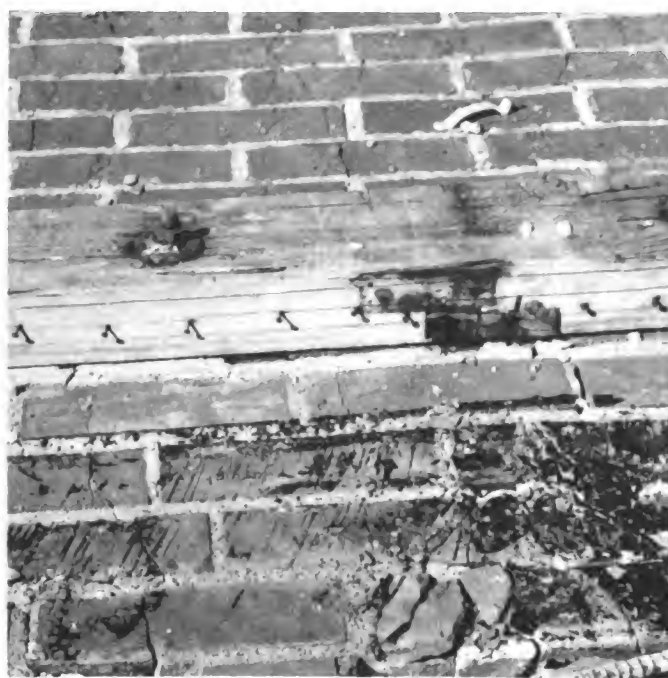
*Figure 5.—Bell Metrics. Closeup of wood ledger still attached to wall after collapse. Note nails in ledger. J. F. Meehan photograph.*

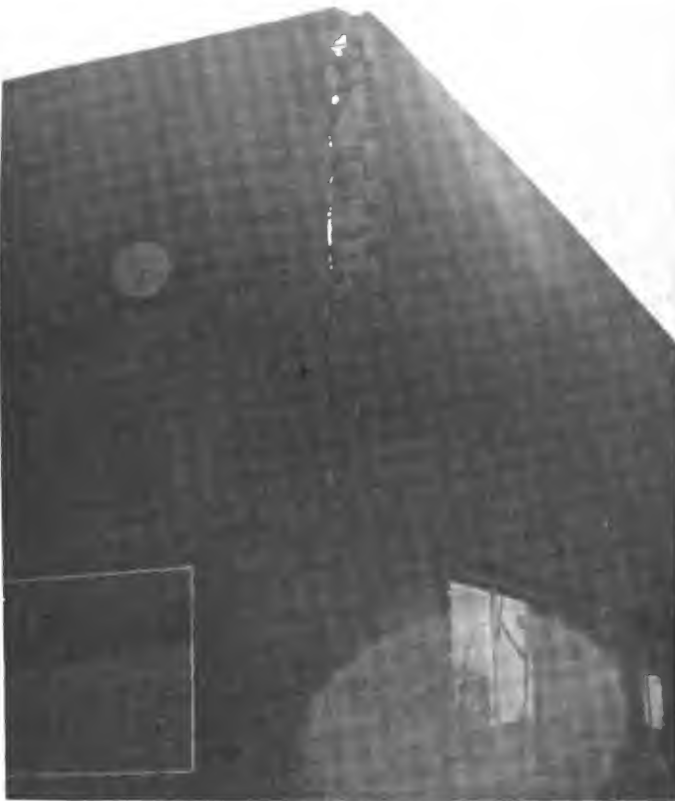
At the northeast corner of the building, walls separated, bricks from the upper portion broke and fell, and a pronounced crack appeared in the middle height of the wall (fig. 6). Anchorage between glued laminated girders and masonry pilaster was lost when the upper 2 feet of masonry developed severe cracking and, in some cases, spalled off (fig. 7).

Figure 6.—Bell Metrics. Northeast corner. Note separation.  
Bell Metrics photograph.

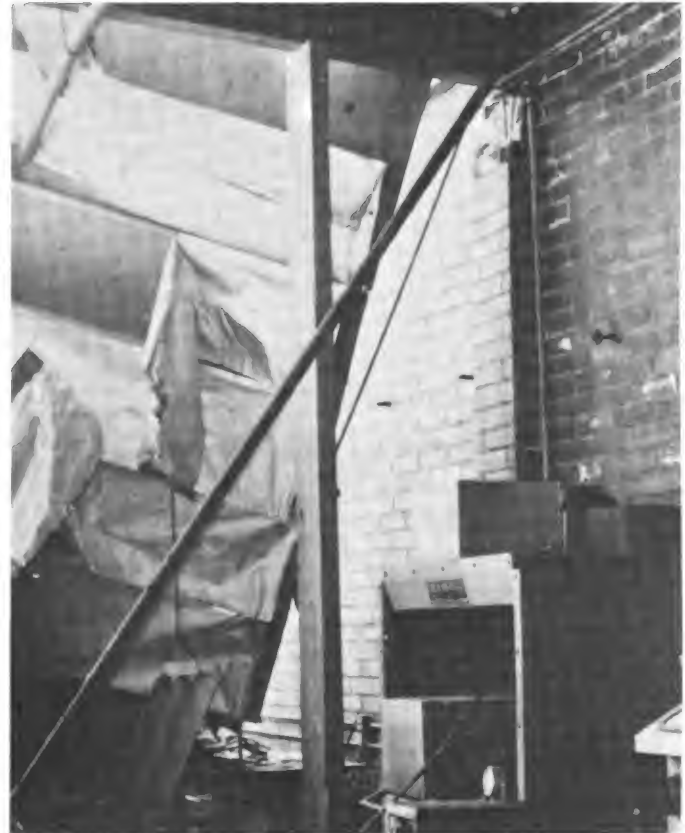
Figure 7.—Bell Metrics. West wall, with top of brick pilaster spalled off. Temporary repairs showing under girder. Bell Metrics photograph.

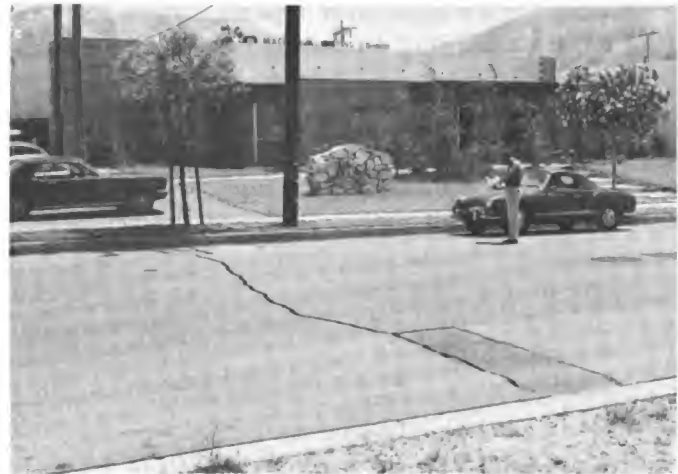
This general area was disturbed by surface effects of ground faulting. At this particular site the soil disturbance consisted of several tension-type cracks running roughly in an east-west direction (fig. 2). In some cases the building floor slab was cracked in the same manner (fig. 3).

Figure 2.—M&L Machine Shop. Front of building. Typical tension crack through street. Wheeler & Gray photograph.

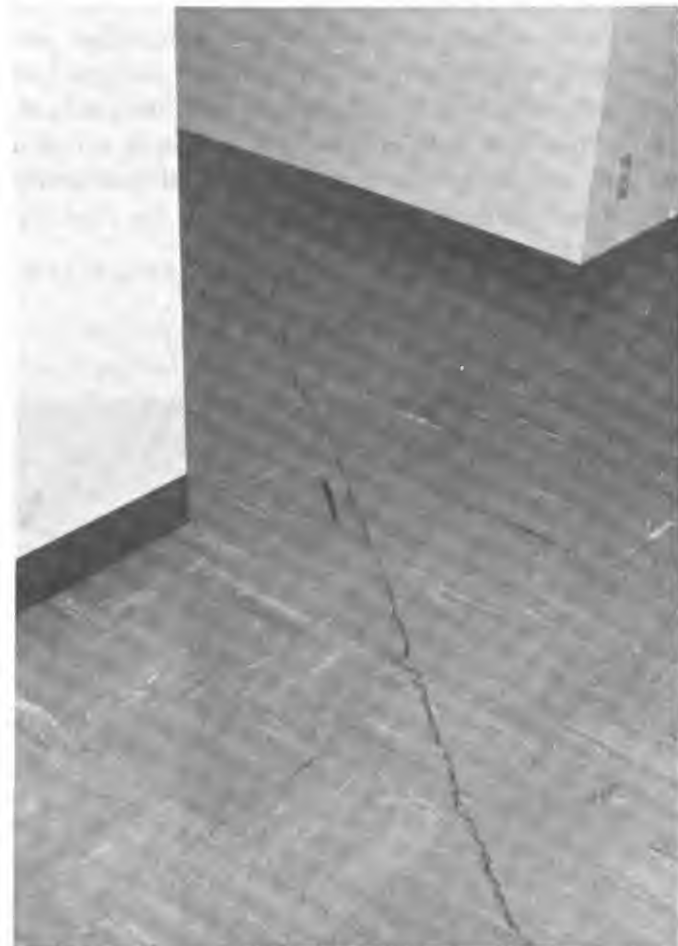
Figure 3.—M&L Machine Shop. Floor slab crack through office area. Wheeler & Gray photograph.

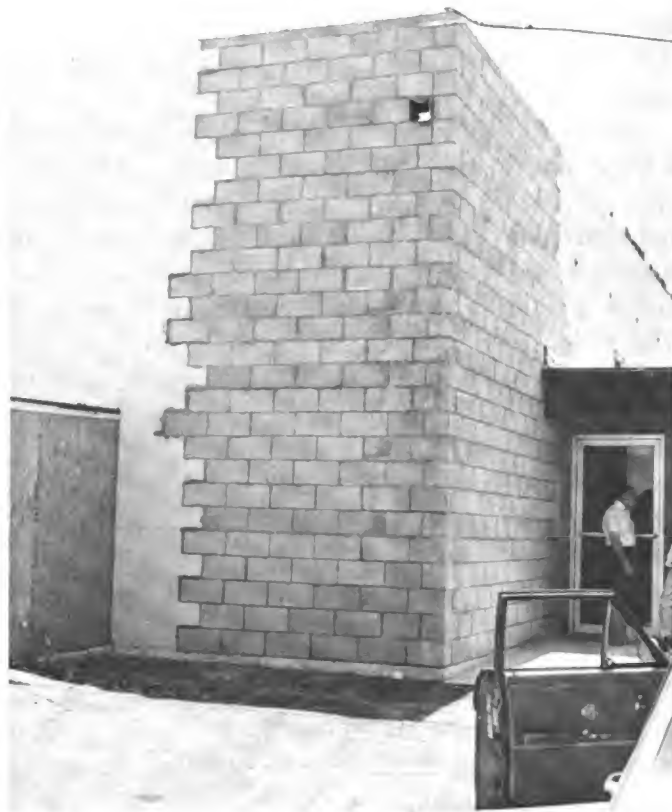
Figure 5.—M&L Machine Shop. Walls separated several inches at this corner. Walls were partially rebuilt (see fig. 4). Wheeler & Gray photograph.

Wall corner separations could be the result of a concentration of horizontal reinforcing at the tops of walls, rather than a more even distribution throughout the full height. Corner damage probably was caused by movements of the roof diaphragm parallel to the shear walls, as well as by excessive diaphragm deflections.

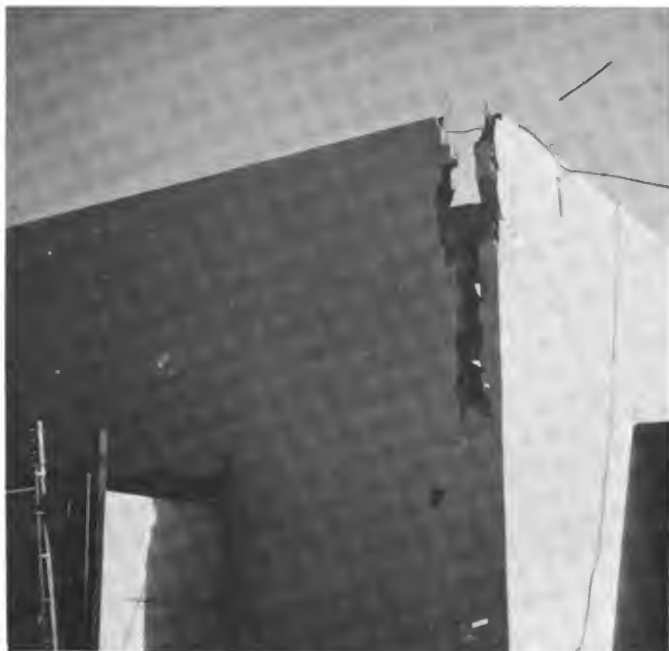
Figure 4.—M&L Machine Shop. Northwest corner. D. F. Moran photograph.

of damage information were reports prepared by the Los Angeles Building Department engineers, photographs, and conversations with the owner. Wall corner damage and corrective repairs are shown in figures 4 and 5.

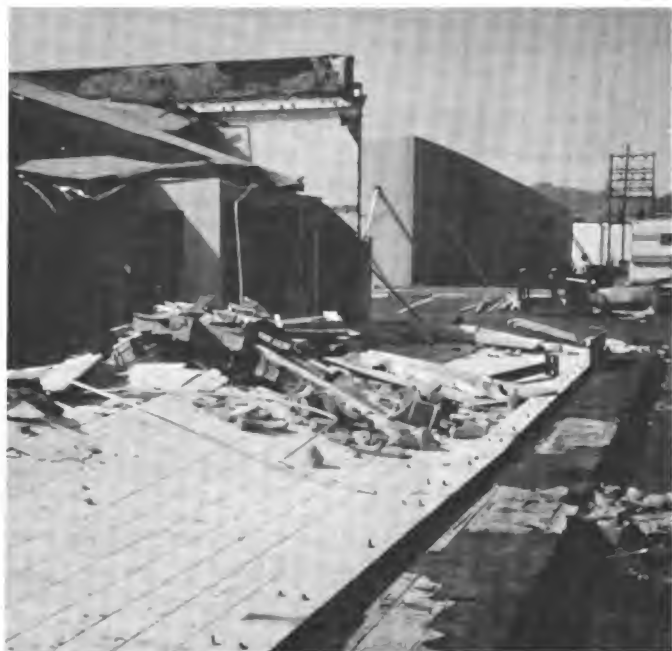
Heaviest damage occurred in the shop area where the entire east wall and portions of the north and south masonry walls completely collapsed (fig. 6). Portions of the roof framing adjacent to the east wall, as well as the last bay adjacent to the west wall (fig. 7), collapsed.

Failure of the plywood-to-ledger connection permitted the purlins to pull out of their seats and to fall to the floor. Wall collapse followed the roof collapse, since the wall would be required to act as a vertical cantilever above the floor slab and could have been subjected to pounding from the roof system before failure.

Figure 6.—M&L Machine Shop. Rear (east) collapse. D. F. Moran photograph.

Damaged masonry walls were removed to undamaged areas and rebuilt to their original conditions. Tops of masonry pilasters were repaired where they were cracked and spalled.

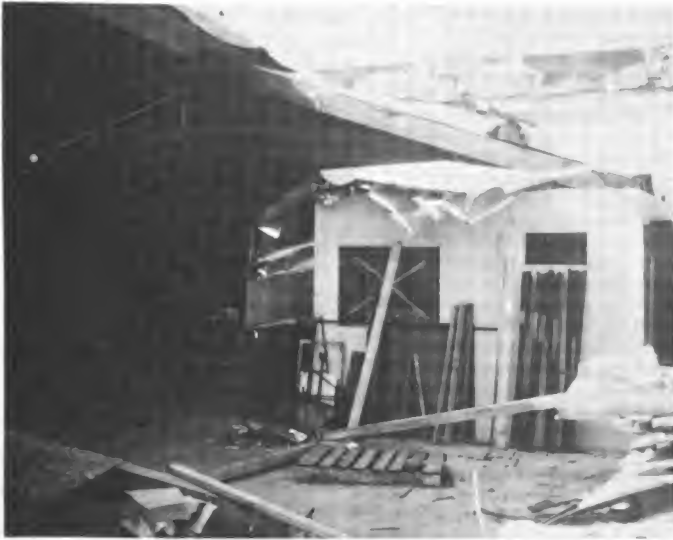
There was considerable evidence of failure of the roof plywood-to-wall connection. Failure consisted mostly of plywood nails pulling through or laterally out of the sheets. In a few cases nails pulled from ledgers, and some ledgers split horizontally along the upper line of bolts. Several sheets of plywood remained attached to the ledger, but nailing failed at the first joint inward from the wall.

Figure 7.—M&L Machine Shop, looking north. Collapsed roof area.  
D. F. Moran photograph.

In the areas where the roof was damaged or separated from the masonry walls, joist anchors or steel straps were added to anchor the masonry walls to the roof.

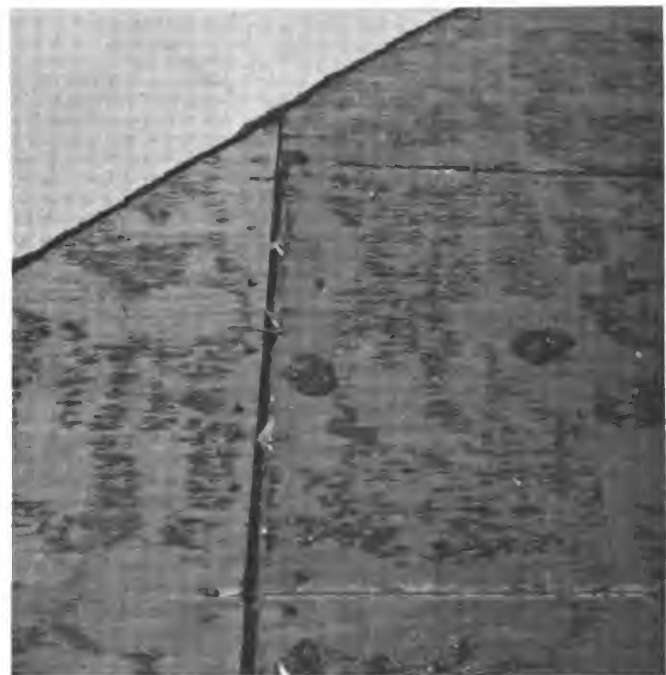
A survey of structural damage to the building showed several types of damage and collapse. The principal cause of collapse was failure of the plywood roof diaphragm connection to the walls. Diaphragm failure consisted of nails pulling through plywood sheets or out of wood ledgers. Some ledgers split horizontally along the upper bolt line. There was some evidence of distress in the roof diaphragm in the area of the reentrant corner (fig. 5). An examination of the outside of the building showed no

Figure 5.—Vector Electronics. Note spreading of roof sheathing over line 6 near reentrant corner. Sheets had been closely butted prior to earthquake. Wheeler & Gray photograph.

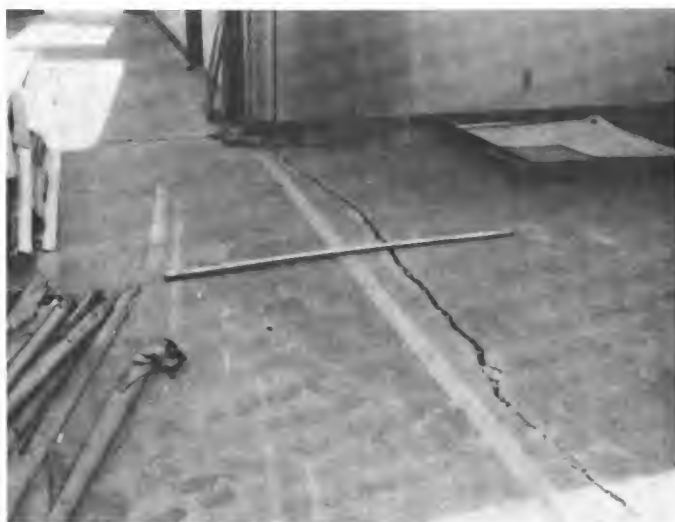
Figure 6.—Vector Electronics. Typical floor slab cracking. Wheeler & Gray photograph.

evidence of vertical displacement. Interior floor slabs showed numerous east-west cracks, which varied up to an inch in width but with minor differential settlement across the line of fracture. A series of cracks, generally in an east-west direction and corresponding to the floor slab cracks, was observed in the pavement in Gladstone Avenue. Typical slab cracking is

shown in figure 6. This cracking or spreading was responsible for stretching the building approximately 6 inches in a north-south direction.

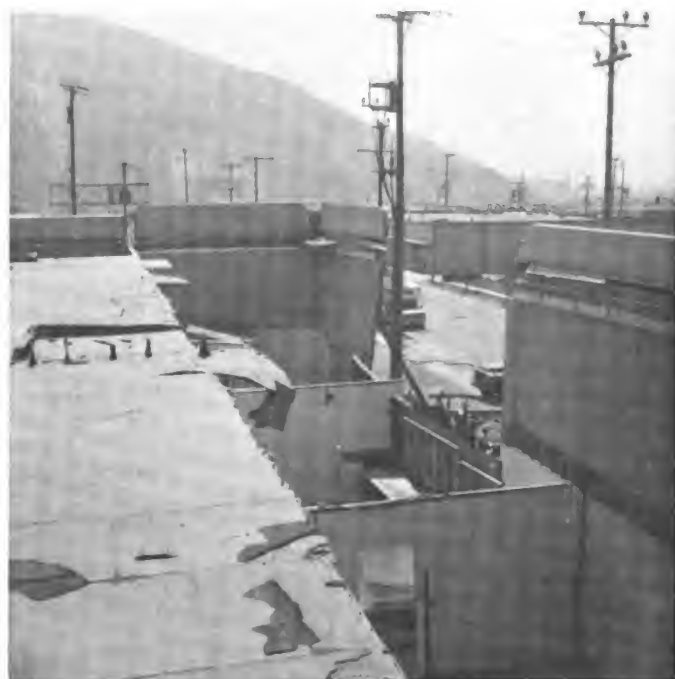
Figure 7.—Vector Electronics. Collapse of roof after connection to wall ledgers failed. Two panels fell to ground on west wall. Wheeler & Gray photograph.

The majority of wall panels on the south and east sides of the building separated from the roof diaphragm, causing the supported roof members to fall to the floor as described above (fig. 7). Wall panels at the southwest corner are shown leaning outward in figure 8. Two panels on the west side fell completely to the ground, and the balance of the dis-

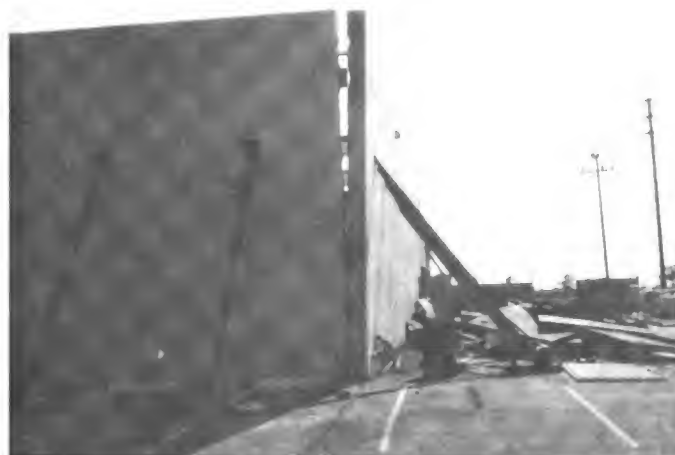
Figure 8.—Vector Electronics. Wall panels leaning outward at southeast corner of building. Shoring has been installed for safety reasons. Wheeler & Gray photograph.

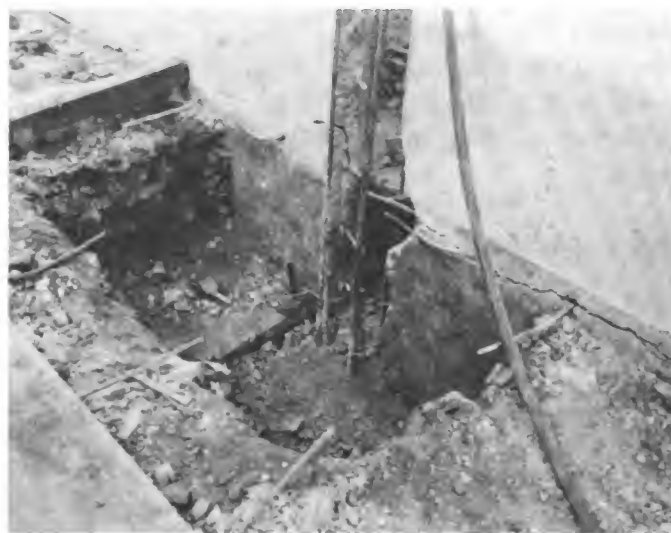
Figure 9.—Vector Electronics. East wall. Note horizontal crack at floorline. Floor slab has been removed and earth excavated at top of footing. Wheeler & Gray photograph.

placed panels remained upright, being restrained by the footing pads and floor slab dowels after the roof was separated. Cracking of wall panels and poured-in-place columns at about the ground line, due to vertical cantilever action, was widespread (fig. 9). Evidence of foundation failure could not be found.

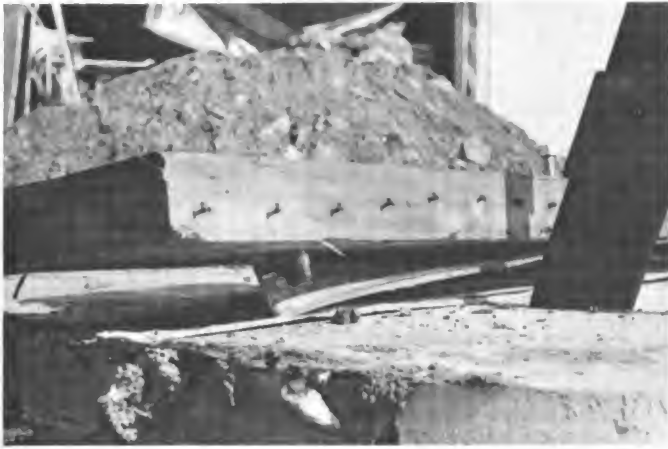
Figure 10.—Vector Electronics. View of wall ledger at collapsed panel of west wall. Note bent perimeter nails used to connect roof sheathing and shallow embedment of expansion-type concrete anchors used. J. F. Meehan photograph.

Due to cantilever action, considerable wall and column cracking occurred after failure of roof-to-wall connections. Expansion-type anchors, used in lieu of cast-in-place anchor bolts in some locations to attach wood ledgers to walls, pulled out (fig. 10). It was observed that these expansion anchors were embedded only slightly over 1 inch for  $\frac{3}{4}$ -inch-diameter anchors.

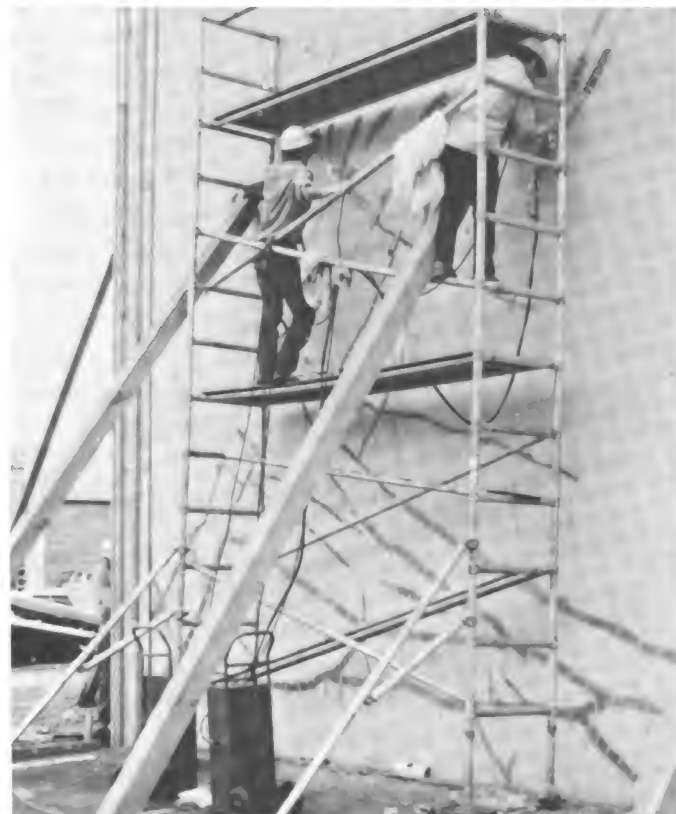
Figure 11.—Vector Electronics. Wall panels not too severely cracked were injected with epoxy as shown. Tests were made to insure penetration and effectiveness of repair. Adhesive Engineering Company photograph.

Remedial repairs were undertaken after a consulting engineering firm, engaged for the repair work, had re-analyzed the structure. The principal repairs consisted of epoxy injection to seal wall cracks (fig. 11); strengthening diaphragm-to-wall ties by addition of strap ties bolted through the wall and connected to roof framing; welding chord reinforcing between the panels to provide for continuity; strengthening miscellaneous roof-beam connections; and adding pipe columns at certain exterior wall locations to carry vertical loads. The plywood roof sheathing adjacent to the walls was rebuilt with  $\frac{5}{8}$ -

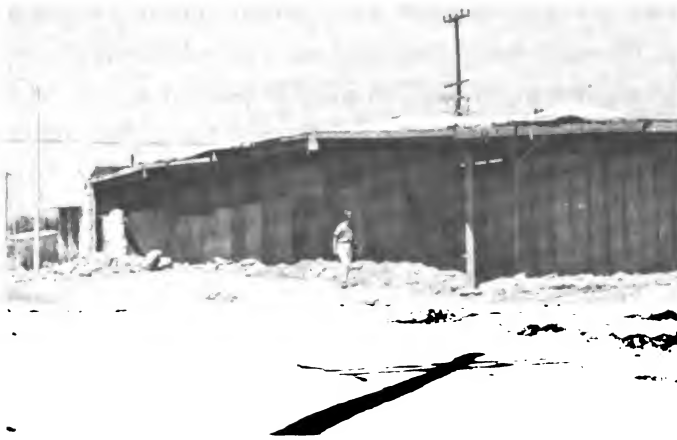
The severe soil upheaval cracked the floor slab at several locations and resulted in sufficiently serious damage to the north and east walls to require their replacement (fig. 2). The northern 20 feet of the

Figure 2.—Wendell Machine Shop. North and east elevations of building. Damaged walls have been removed and will be rebuilt. Wheeler & Gray photograph.

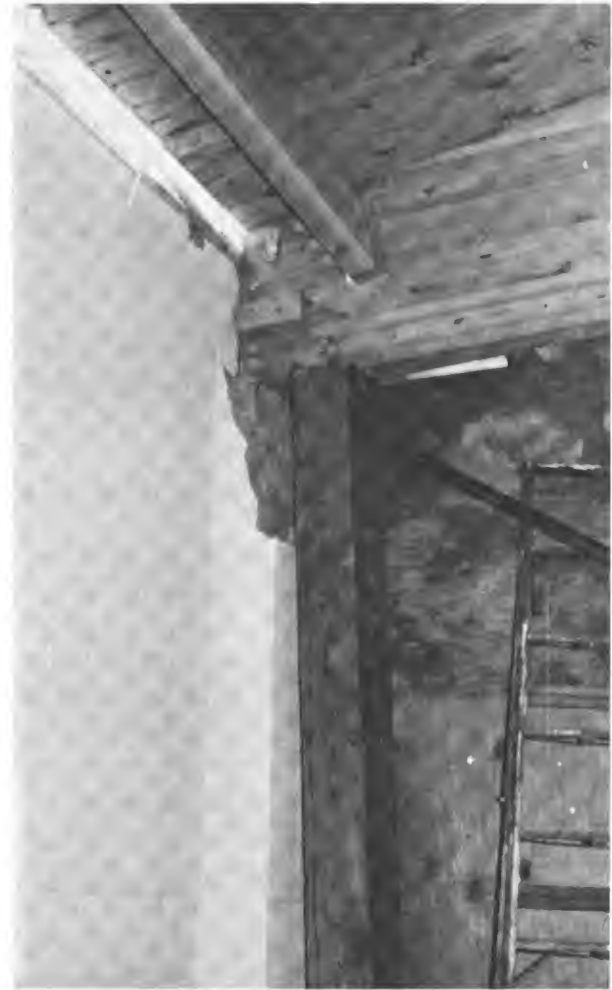
Figure 4 shows separation of the glued laminated roof girder from the reinforced concrete block pilasters at the east and west walls. Severe spalling occurred in the upper portion of the pilasters when the forces exceeded the capacity of the connection (fig. 1, section C-C).

Figure 4.—Wendell Machine Shop. Pilaster located at west wall. Damage to upper portion at junction with glued laminated girder. Shoring of girder is still in place. Wheeler & Gray photograph.

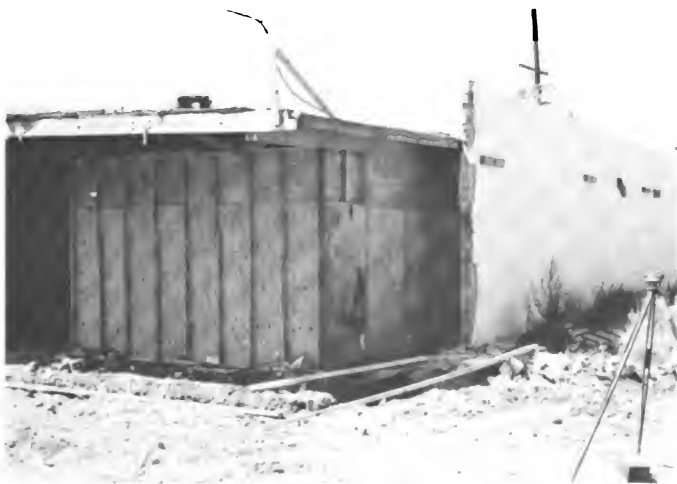
west wall also was affected by the ground motions. Severe cracking occurred, making it necessary to replace that portion of the west wall (fig. 3). The remainder of the west wall was pushed 2 inches out of plumb, but remained in reparable condition.

Figure 3.—Wendell Machine Shop. Northwest corner of building. Walls to be replaced have been removed. Wheeler & Gray photograph.

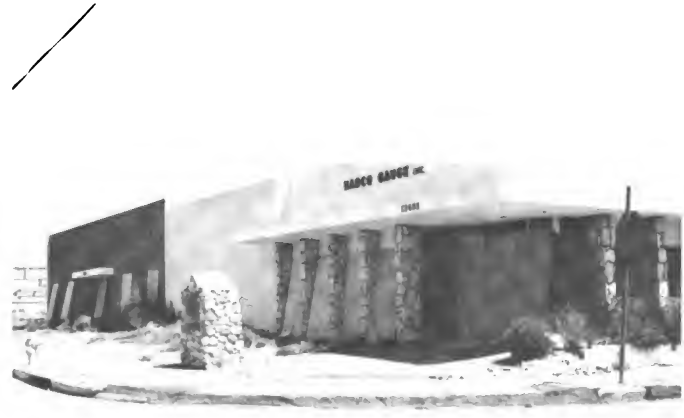
Figure 5.—Wendell Machine Shop. Front (south) wall, looking northwest. This wall was not damaged although extensive window glass breakage occurred. Wheeler & Gray photograph.

The front (south) portion of the building parallel to Foothill Boulevard was not affected structurally, and the damage was limited to cracking of plaster finishes and general glass window breakage (fig. 5). The good structural performance of this portion of the building can be attributed to the stiffening action of the several wood partition walls in that area.

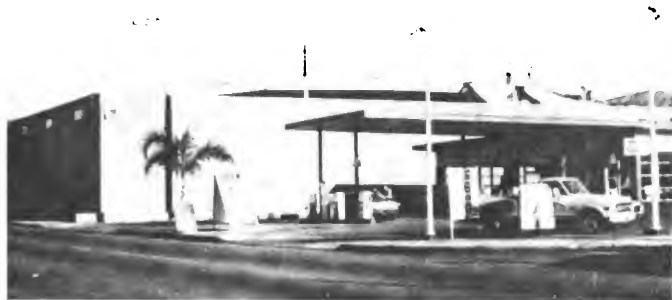
Figure 2.—Bennett Industries. Before repair work. Note open area at top of east wall. Rudy Gunnarson photograph.

Damage was limited primarily to the east wall (figs. 2 and 3), a part of which was torn loose from the roof.

Discussions with building department personnel indicate the partial cause of damage at this particular point was heavy rolls of paper falling against the wall. The paper is reported to have been stacked in a storage area adjacent to the wall.

The replacement cost of the structure, prior to the earthquake, can be estimated at about \$12 per square foot, or a total cost of \$495,000. Repairs to the damaged wall, estimated at about \$10,000, consisted of replacement of damaged material to its preearthquake condition.

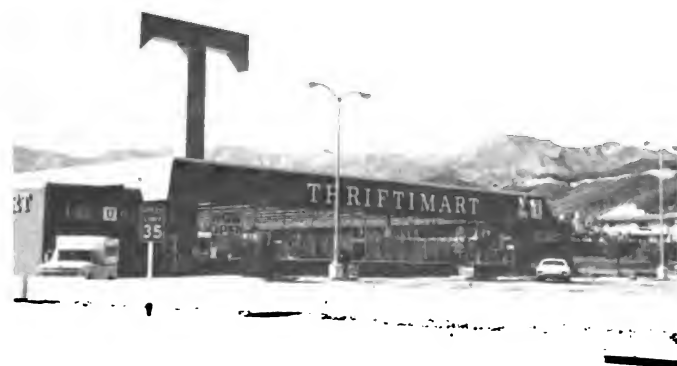
Figure 2.—Thriftmart Market. Front (north) wall. Note masonry wall segments at each corner. J. Kesler photograph.
